Creative services | Restoration sample

Project details

Window description

- 27-1/8" x 42-7/8" (68.9 cm x 108.9 cm)
- Leaded panel in clear glass texture with jewels
- Bevel cluster in centre

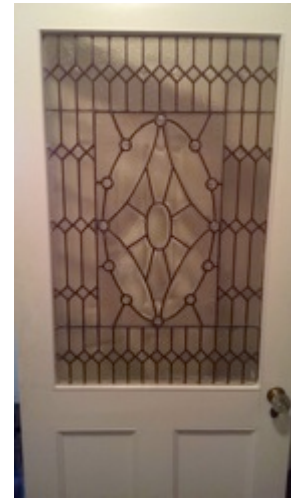
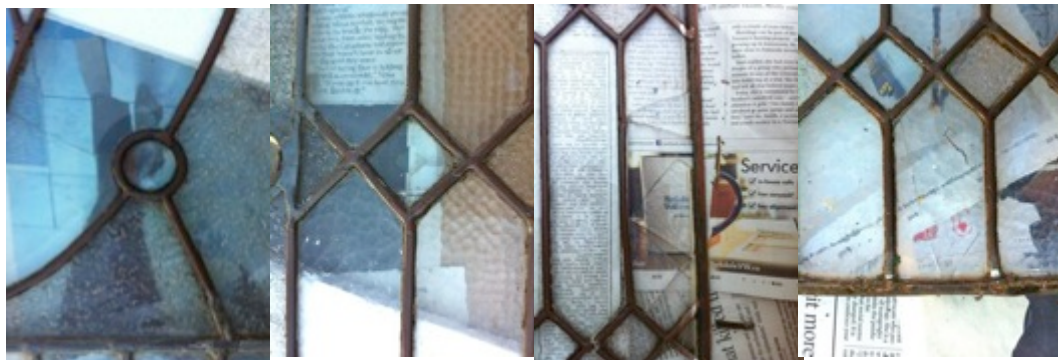
- Antique lead severely deteriorated
- Window sagging in frame
- Central bevel cluster popping out
- Broken oval bevel in central cluster
- Broken glass sections

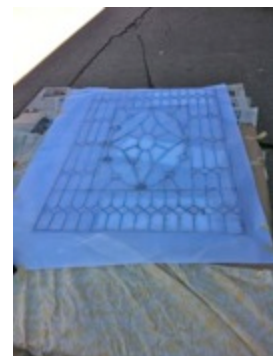
- Securely remove window from residence
- Create a rubbing of original window for reconstruction purposes

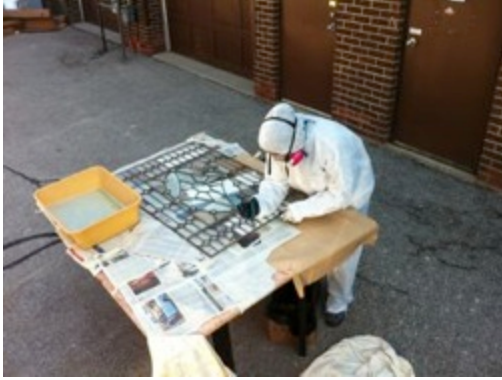
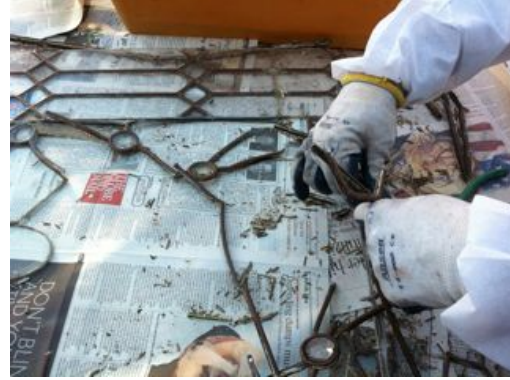
- Dismantle window under **conservation safety guidelines**

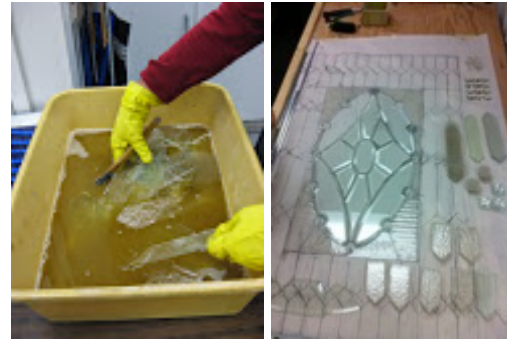
- Wash all glass to remove detritus
- **Environmentally recycle** old lead

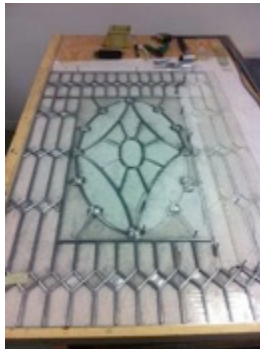
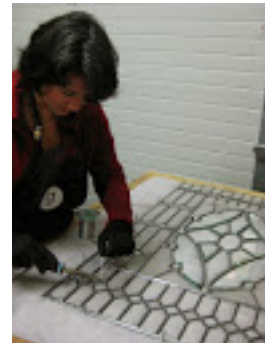
- Reconstruction includes replacement of broken glass, custom beveling, reinforced lead for verticals for hidden support and replacement of rebar

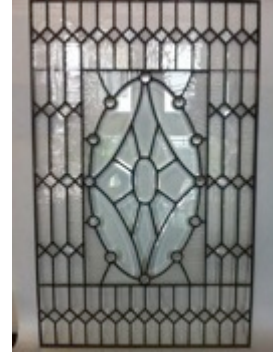
- Glazing
- Apply patina and polish
